PROPERTY CONDITION SURVEY - COMMERCIAL/INDUSTRIAL

AD2696A

Mears and Church Street
MUDGEES NSW 2850

145 Church Street
MUDGEES NSW 2850

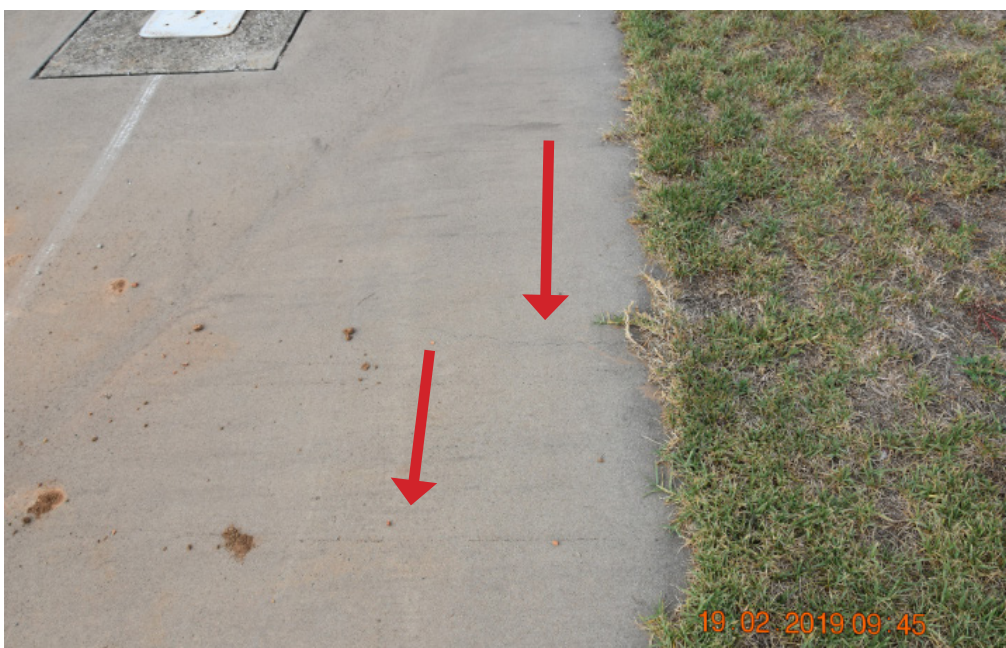
Figure: 0228

Fine cracking in the concrete slab on the north side of the helipad.

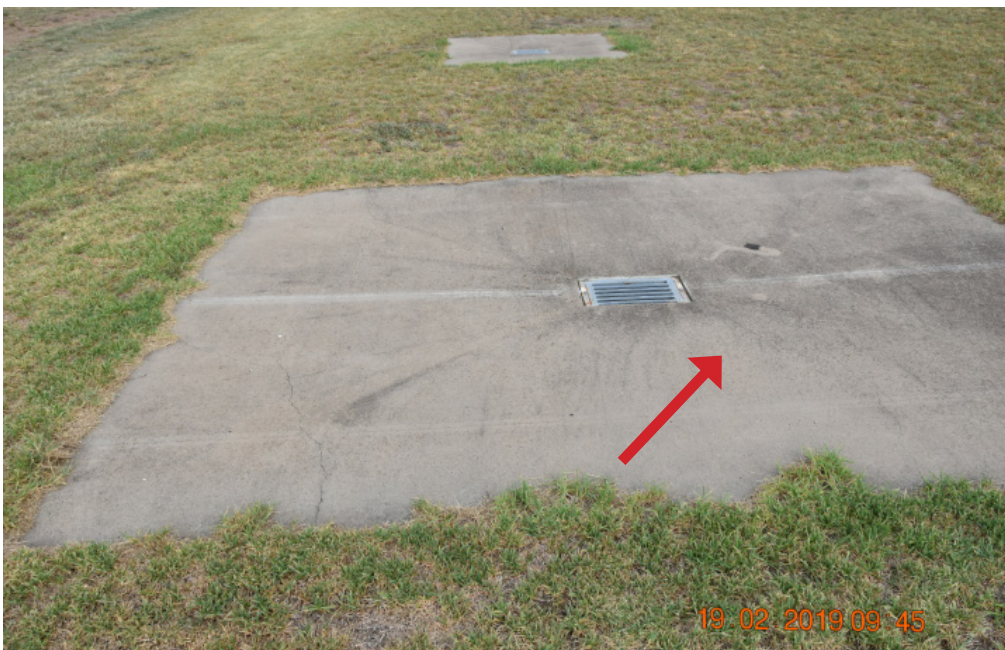
Figure: 0233

General view of the second concrete slab from the east on the north side of the heli-pad. Showing cracking.

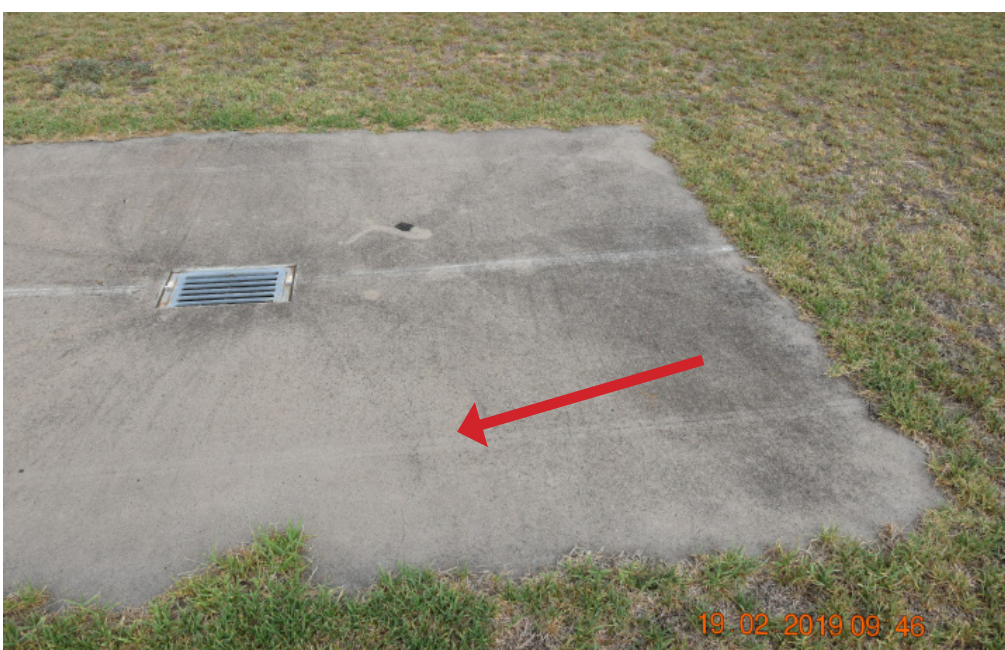
Figure: 0234

General view of the second concrete slab from the east on the north side of the heli-pad. Showing cracking.

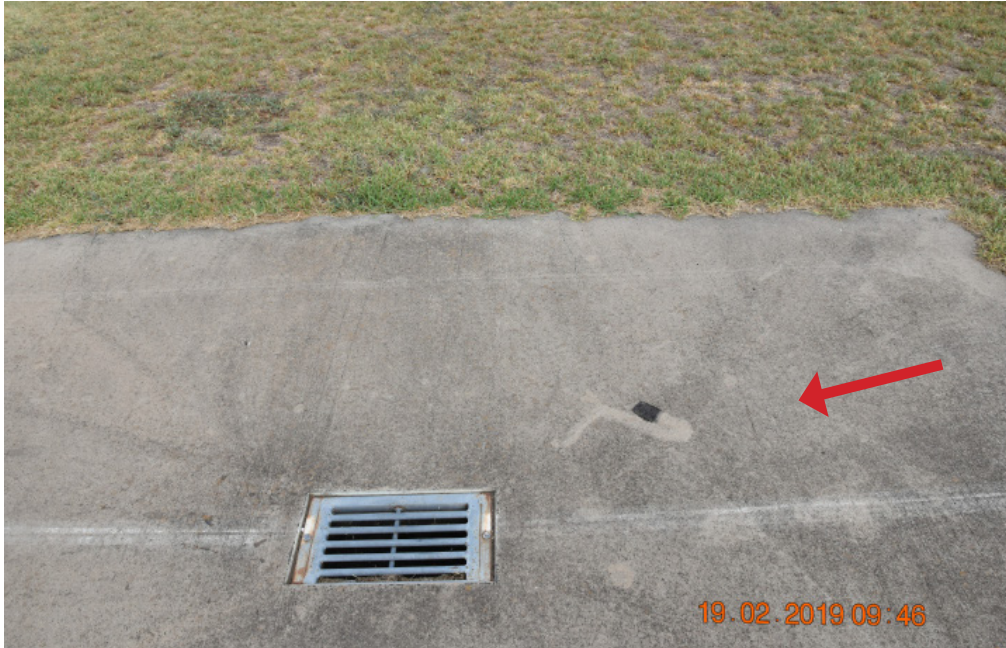
Figure: 0235

General view of the second concrete slab from the east on the north side of the heli-pad. Showing crack-ing.

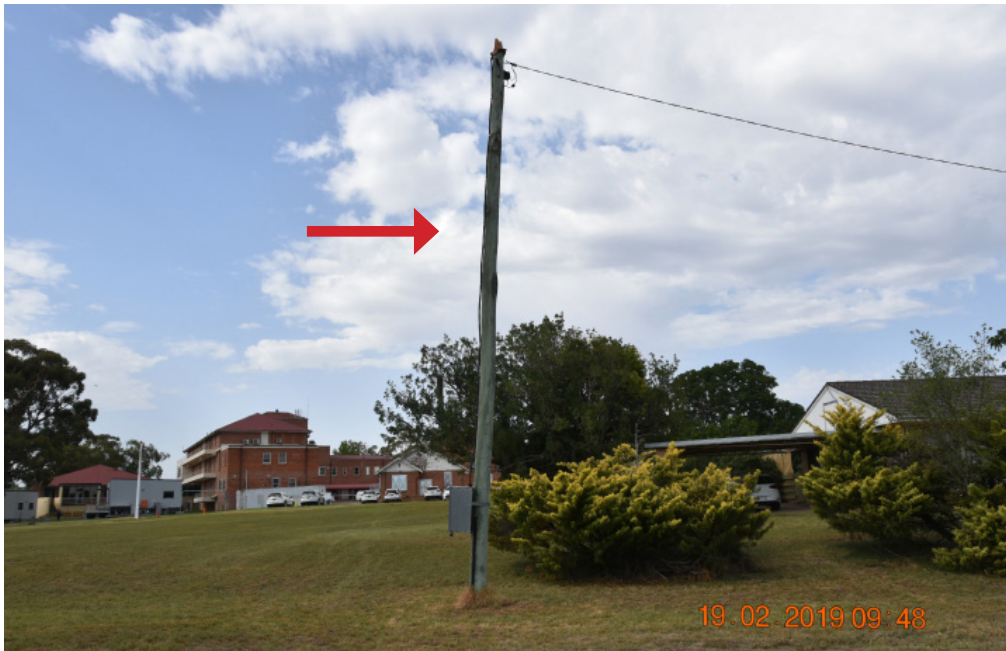
Figure: 0248

General view of the power pole on the north side of the heli-pad. Showing leaning.

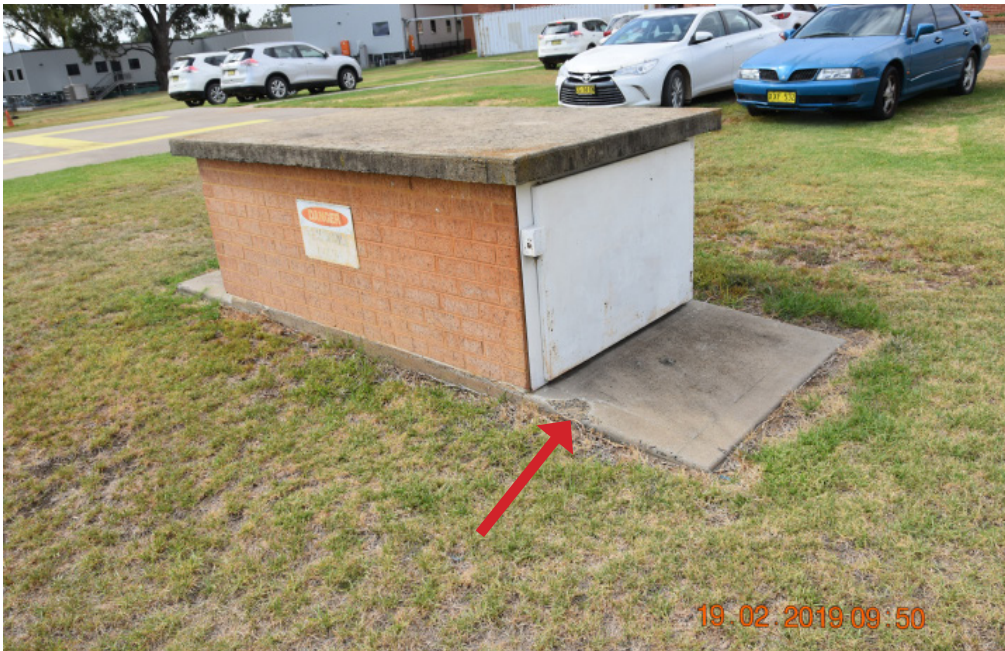
Figure: 0253

General view of the fuel storage adjacent to the helipad. Showing chipping.

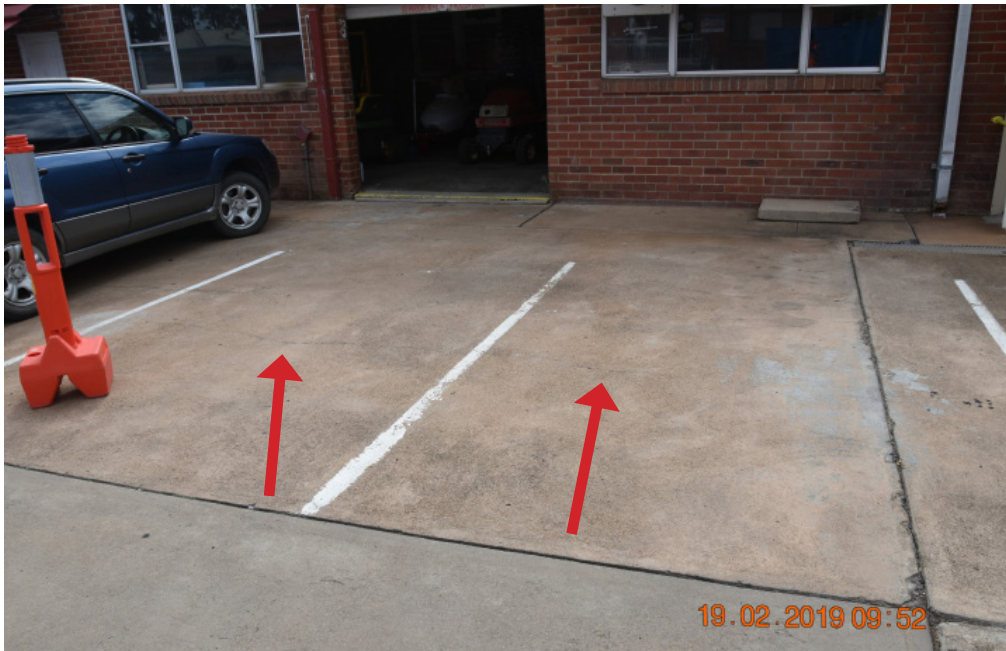
Figure: 0268

General view of the carpark at the south-west corner of the helipad. Showing cracking.

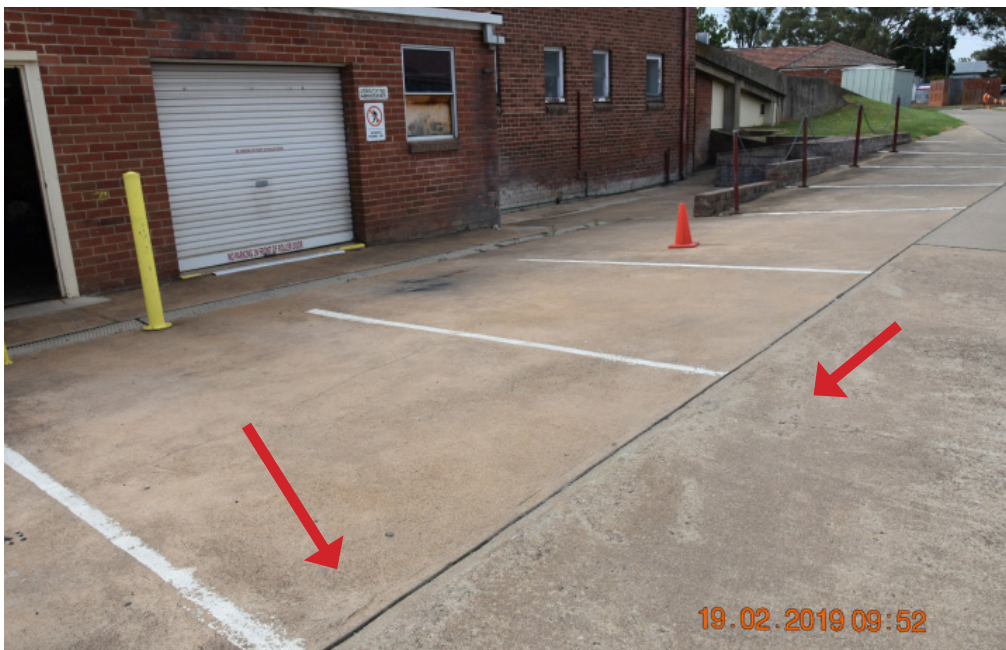
Figure: 0269

General view of the carpark at the south-west corner of the helipad. Showing cracking.

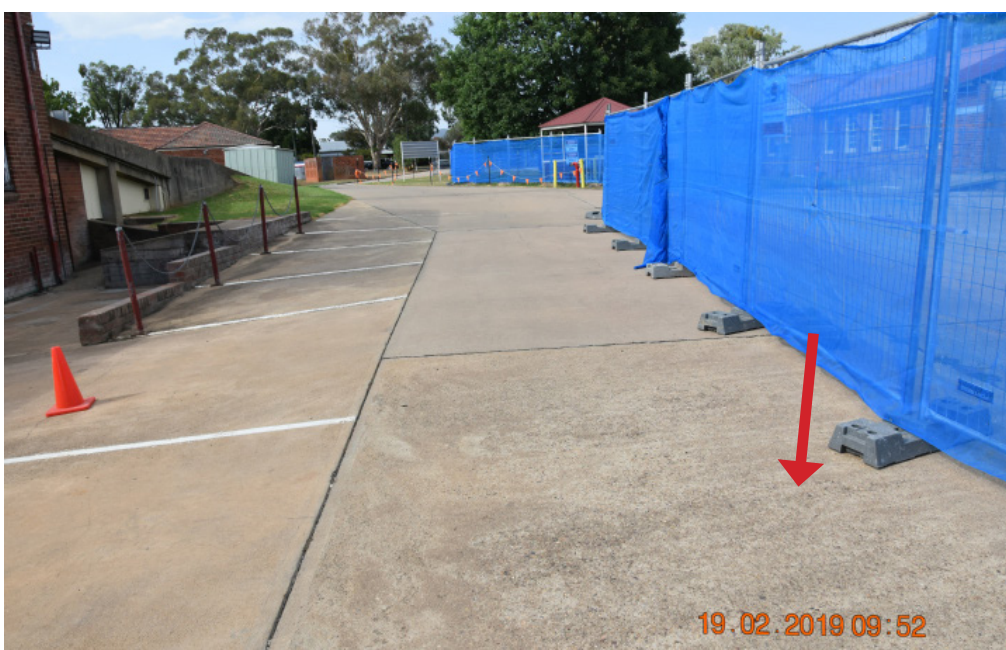
Figure: 0270

General view of the south driveway to the hospital. Showing cracking.

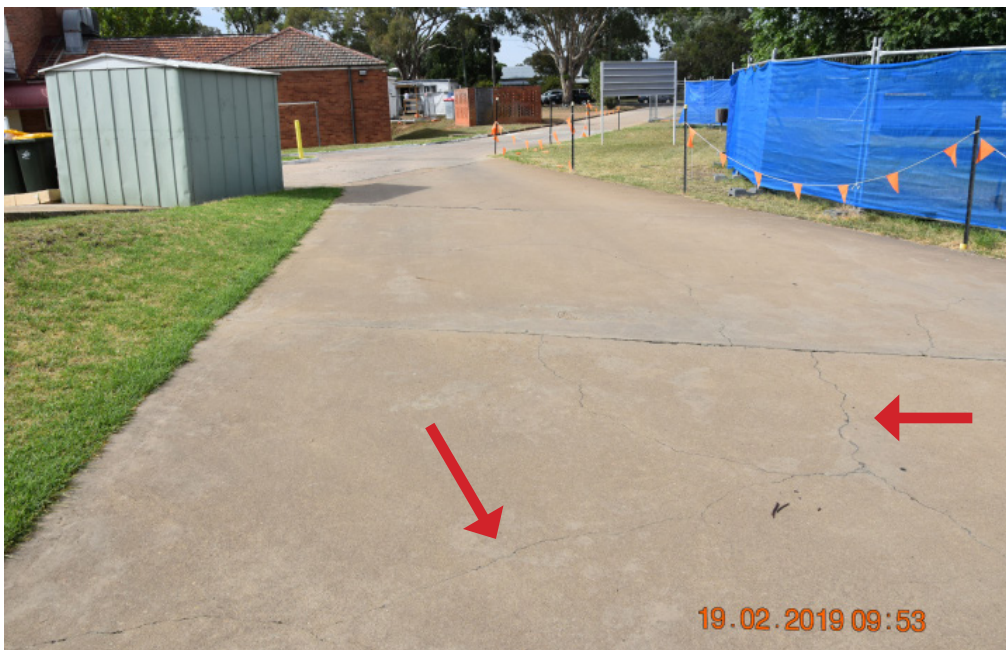
Figure: 0275

General view of the south driveway to the hospital. Showing cracking.

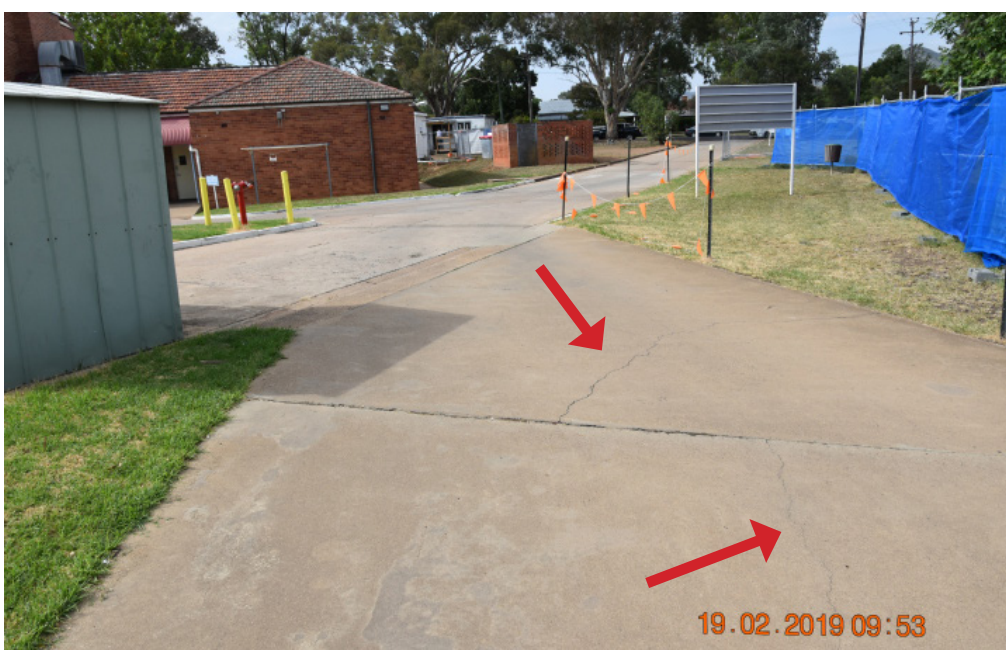
Figure: 0276

General view of the south driveway to the hospital. Showing cracking.

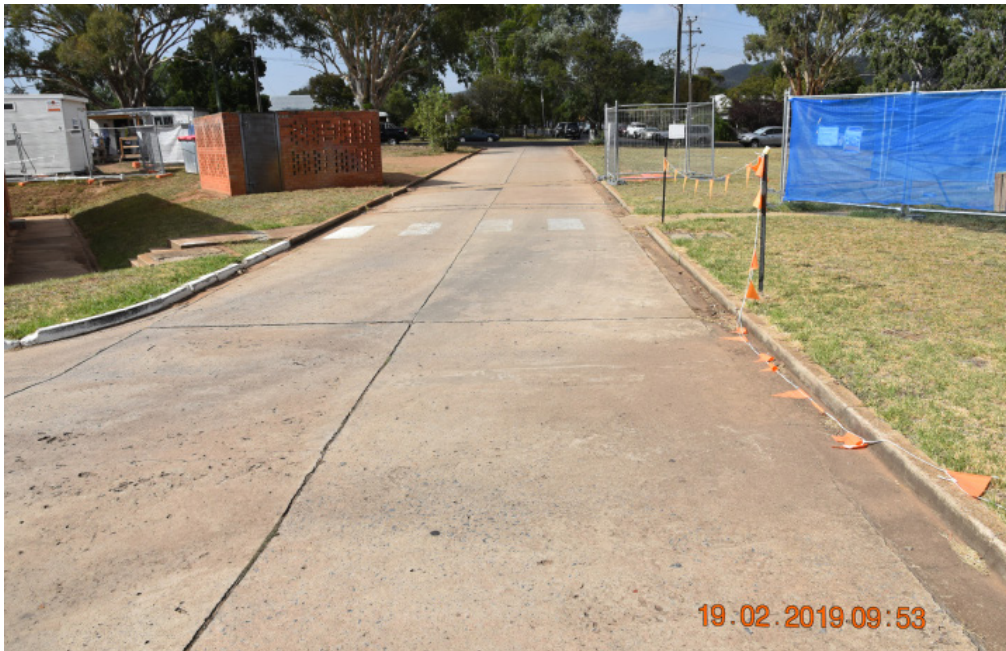
Figure: 0277

General view of the south driveway to the hospital, looking south.

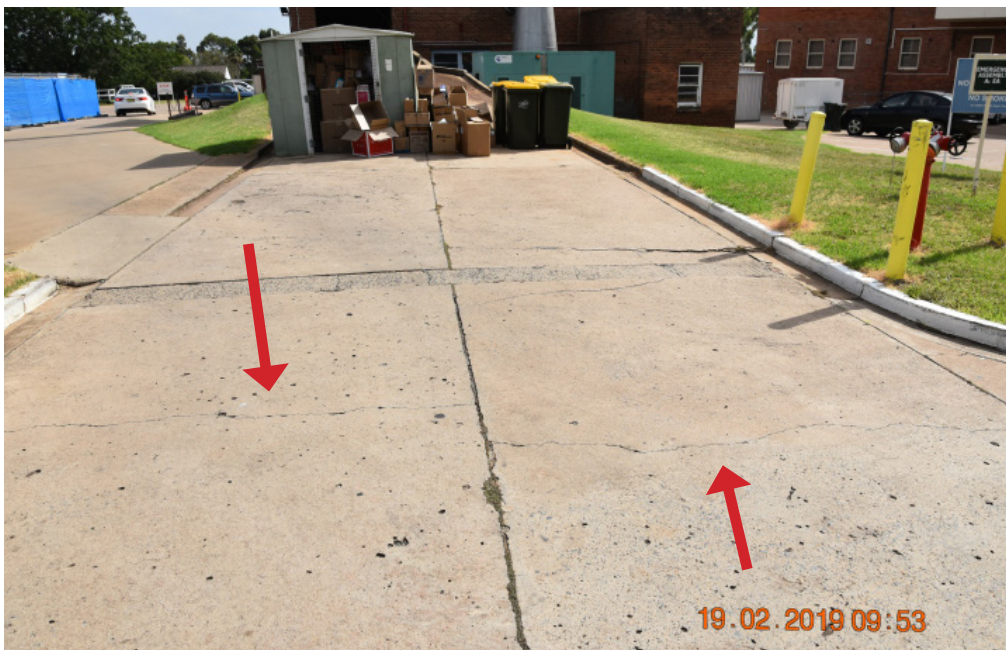
Figure: 0278

General view of the south driveway to the hospital, looking north. Showing cracking.

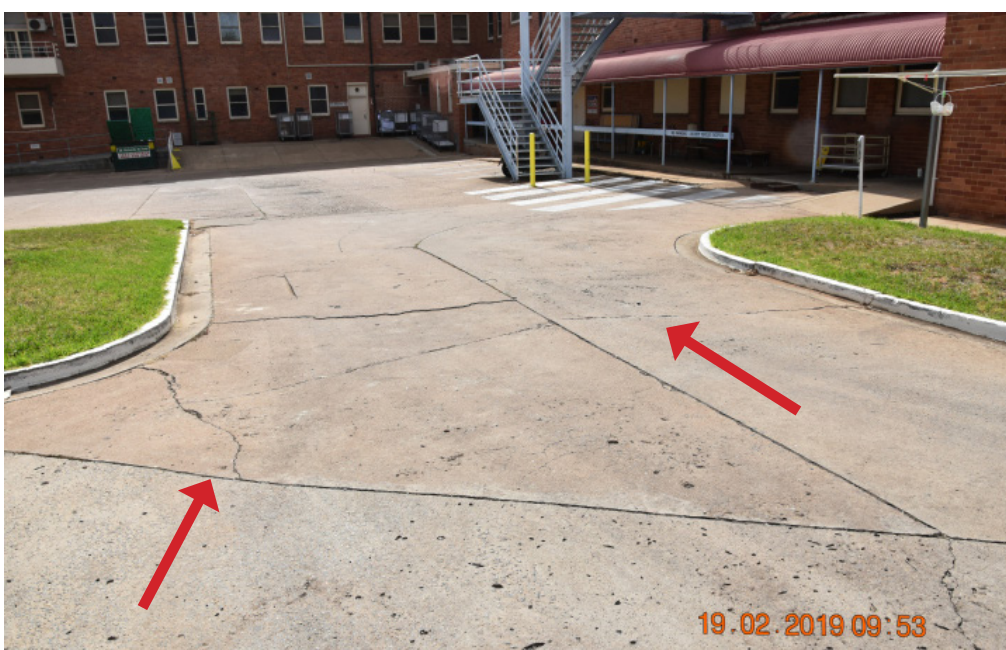
Figure: 0279

General view of the branch carpark, adjacent to the hospital. Showing cracking. Typical throughout.

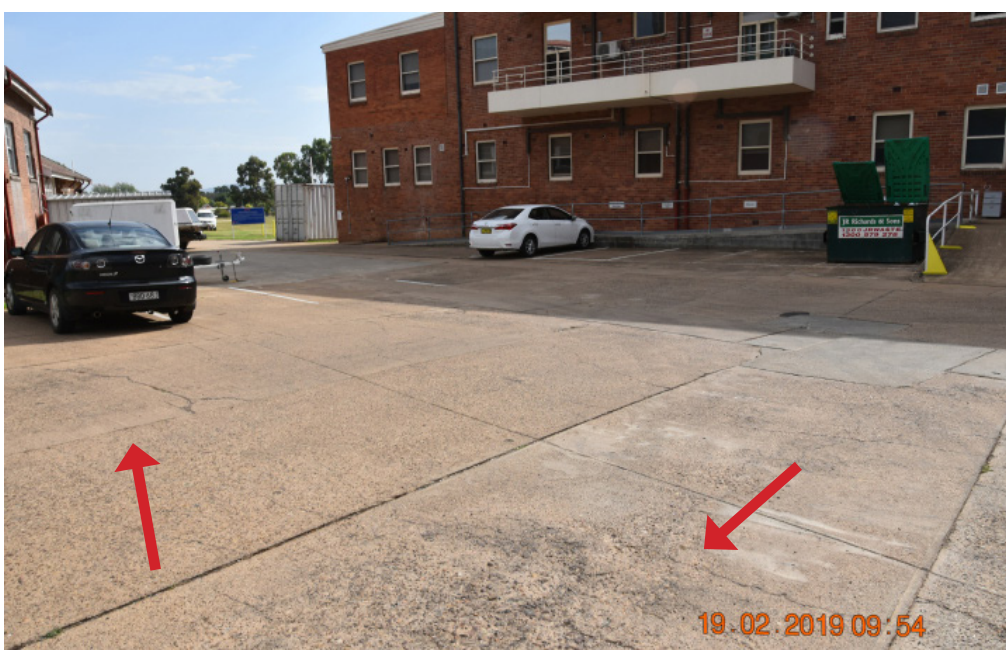
Figure: 0282

General view of the branch carpark, adjacent to the hospital. Showing cracking. Typical throughout.

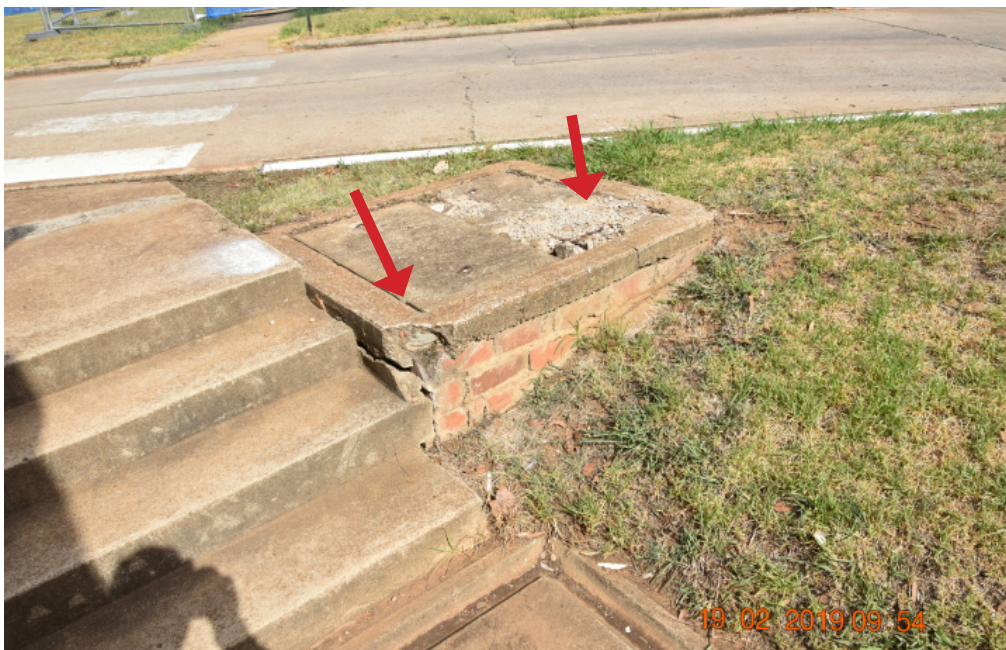
Figure: 0287

General view of the pit lid adjacent to the south driveway to the hospital. Showing damage.

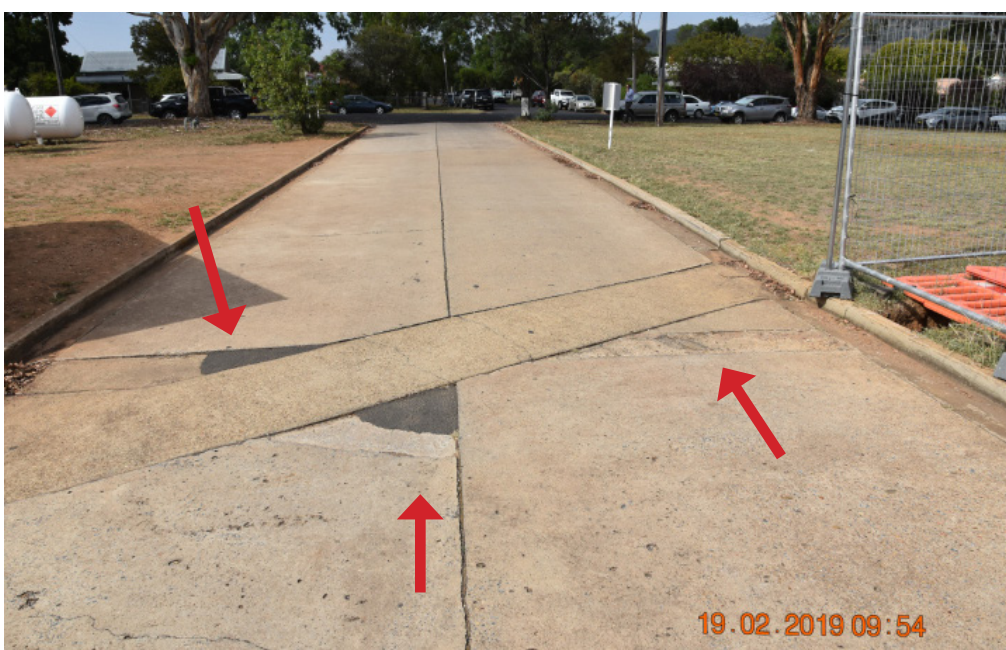
Figure: 0288

General view of the south driveway to the hospital. Showing poor condition.

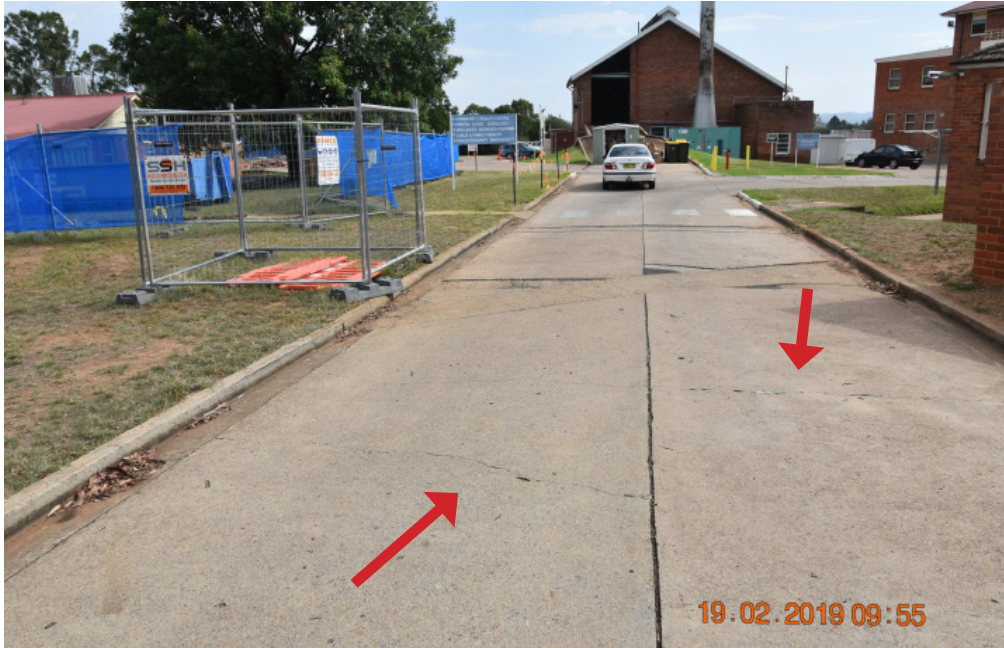
Figure: 0292

General view of the south driveway to the hospital, looking north. Showing crack-ing.

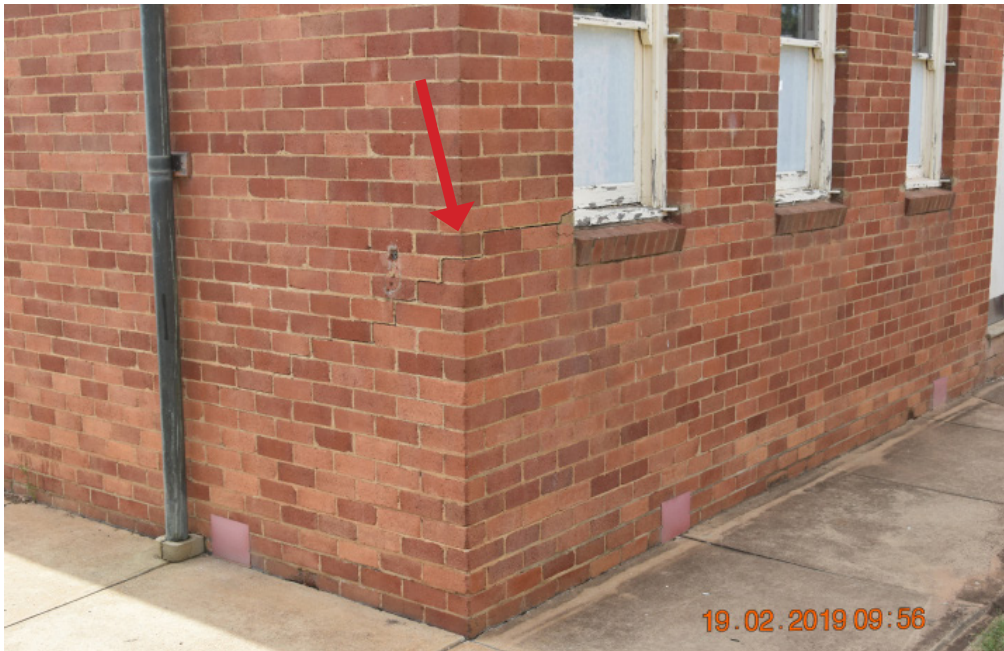
Figure: 0295

Slight stepped crack-
ing in the west wall
of the hospital, at
approximately 30
metres from the south
driveway.

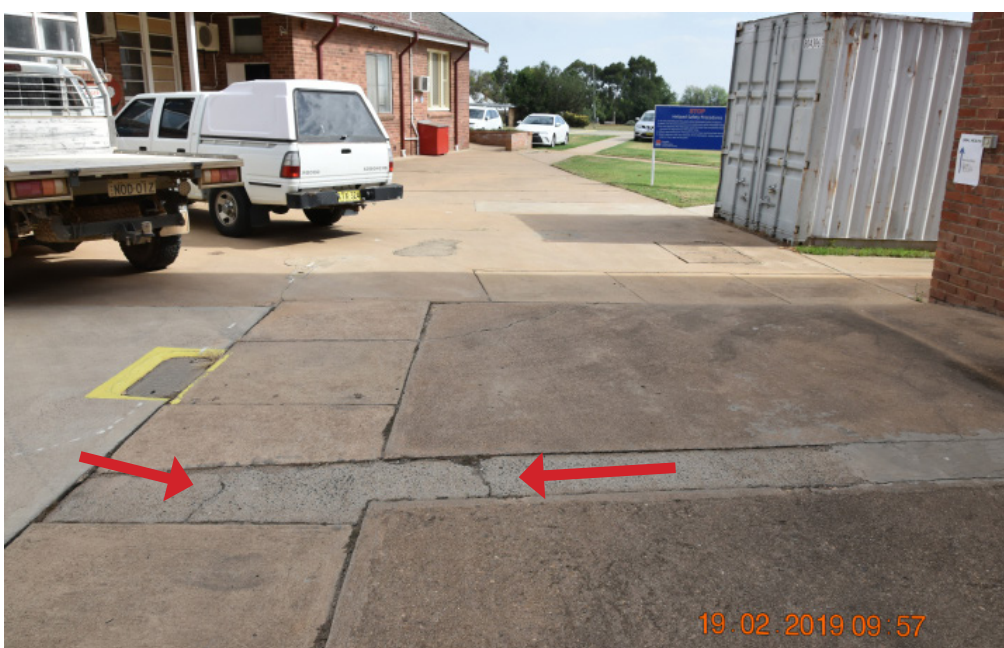
Figure: 0297

General view of the
paving outside the
east hospital building.
Showing cracking.

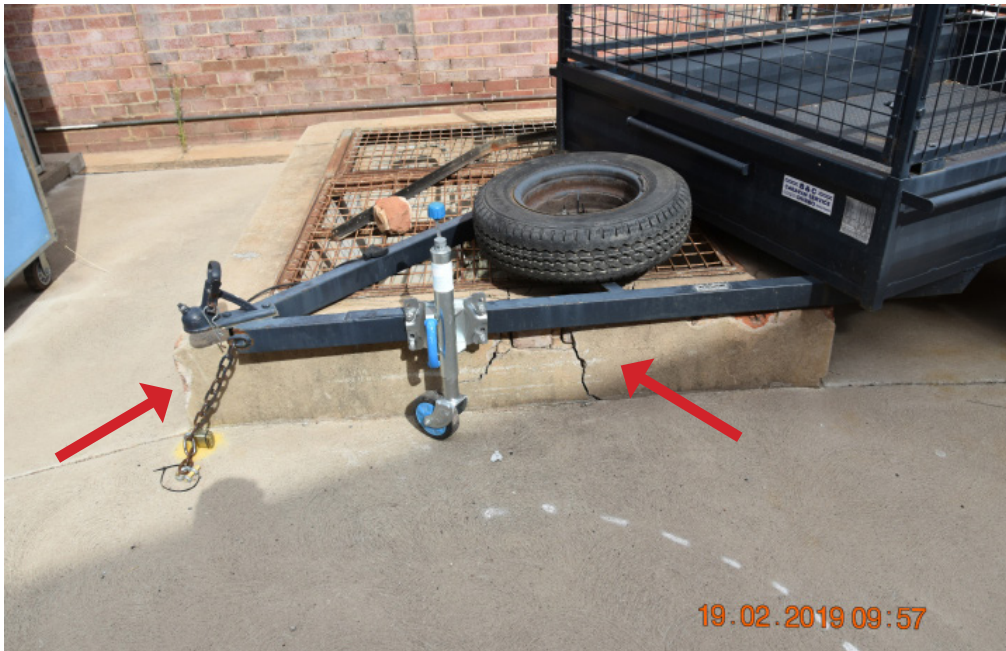
Figure: 0298

Damage in the drainage pit outside the east hospital building.

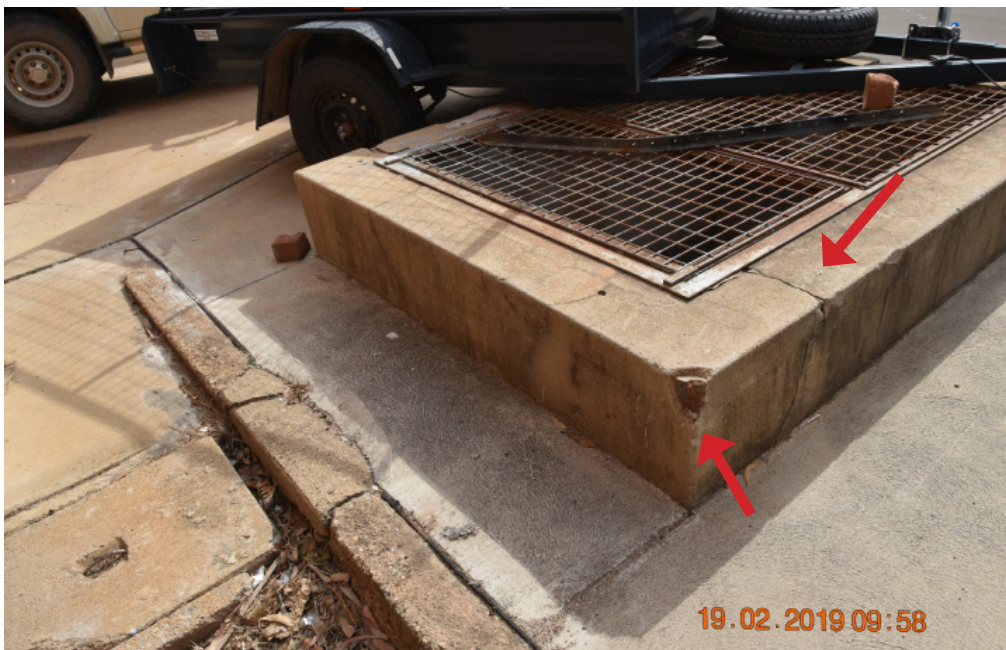
Figure: 0299

Damage in the drainage pit outside the east hospital building.

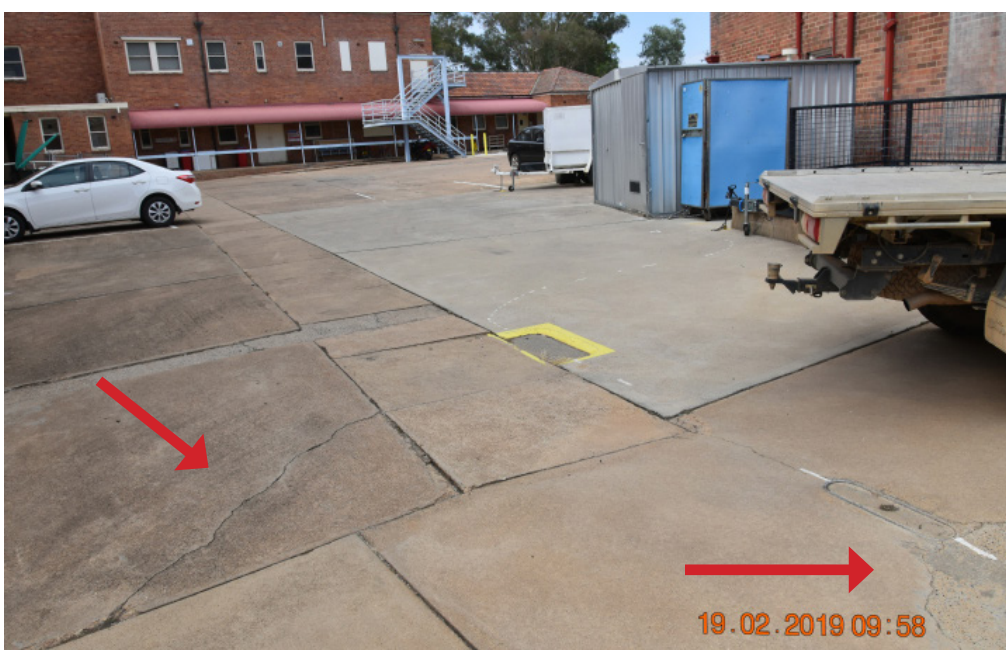
Figure: 0300

General view of the carpark outside the oral health building. Showing cracking.

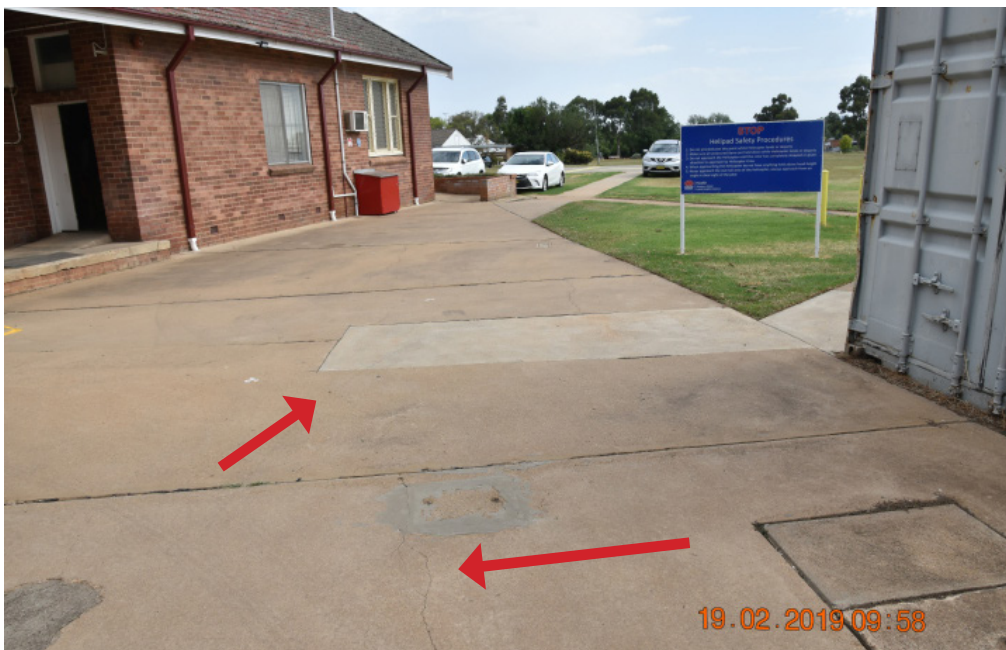
Figure: 0302

General view of the carpark outside the oral health building. Showing cracking.

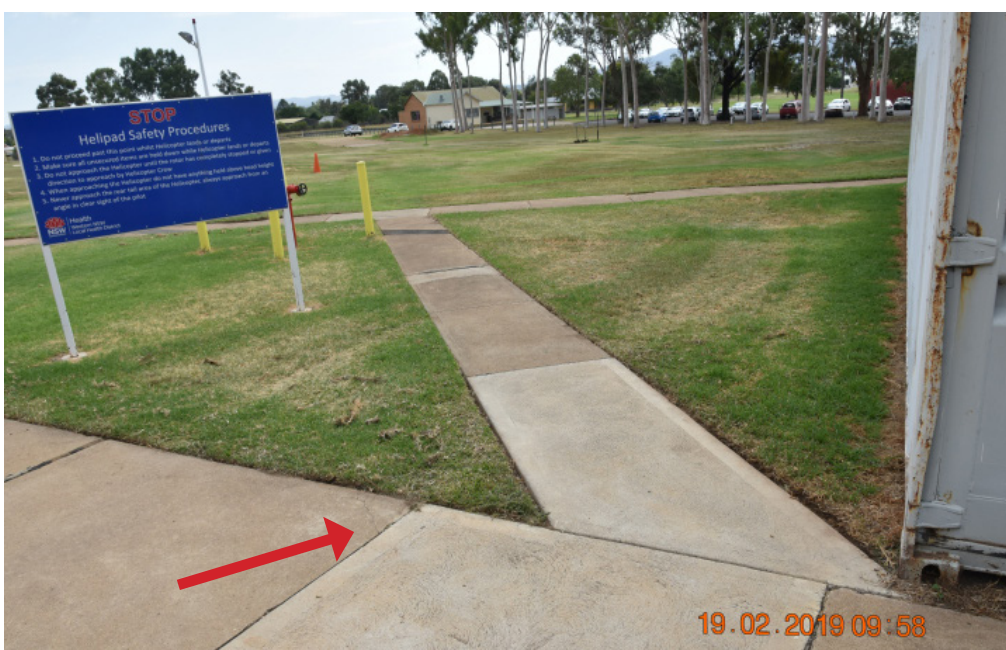
Figure: 0303

General view of the pathway near the southeast corner of the helipad. Showing cracking.

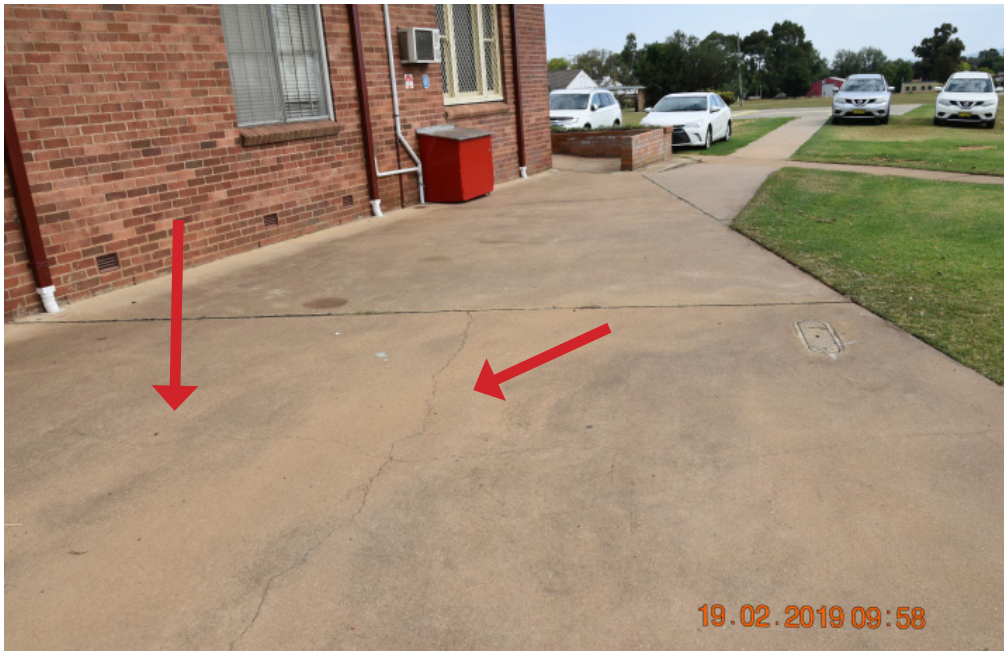
Figure: 0304

General view of the pathway near the southeast corner of the helipad. Showing cracking.

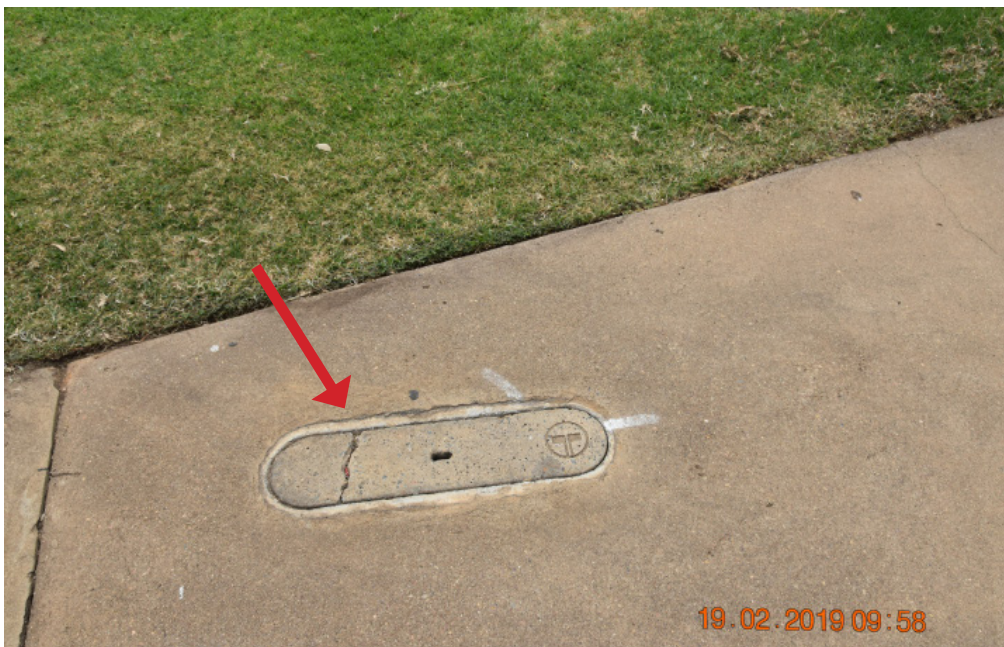
Figure: 0305

General view of the pit lid in the pathway near the southeast corner of the helipad. Showing damage.

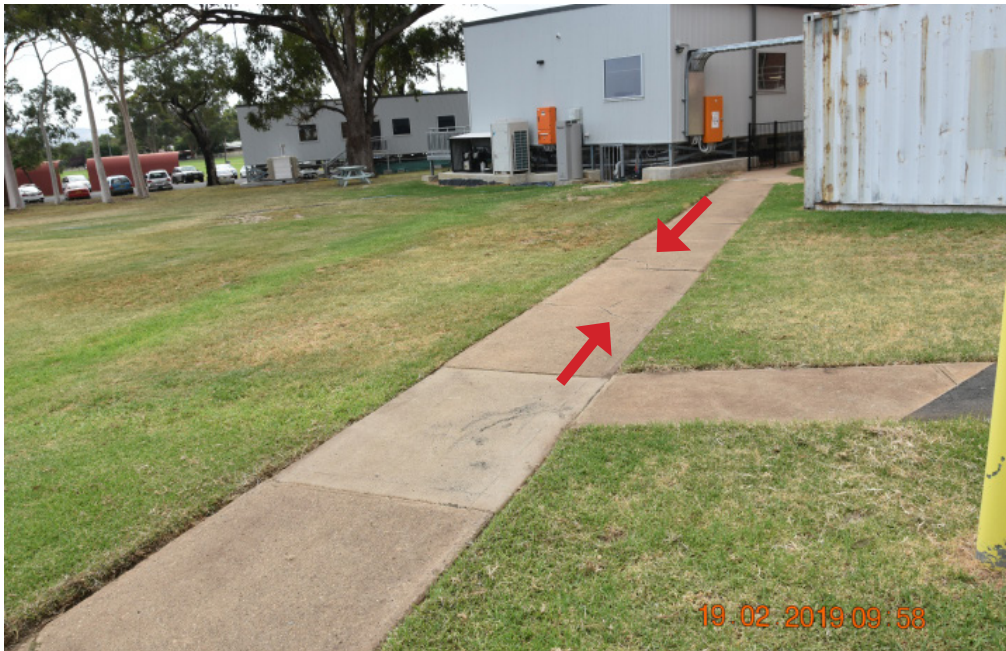
Figure: 0307

General view of the pathway near the southeast corner of the helipad. Showing cracking.

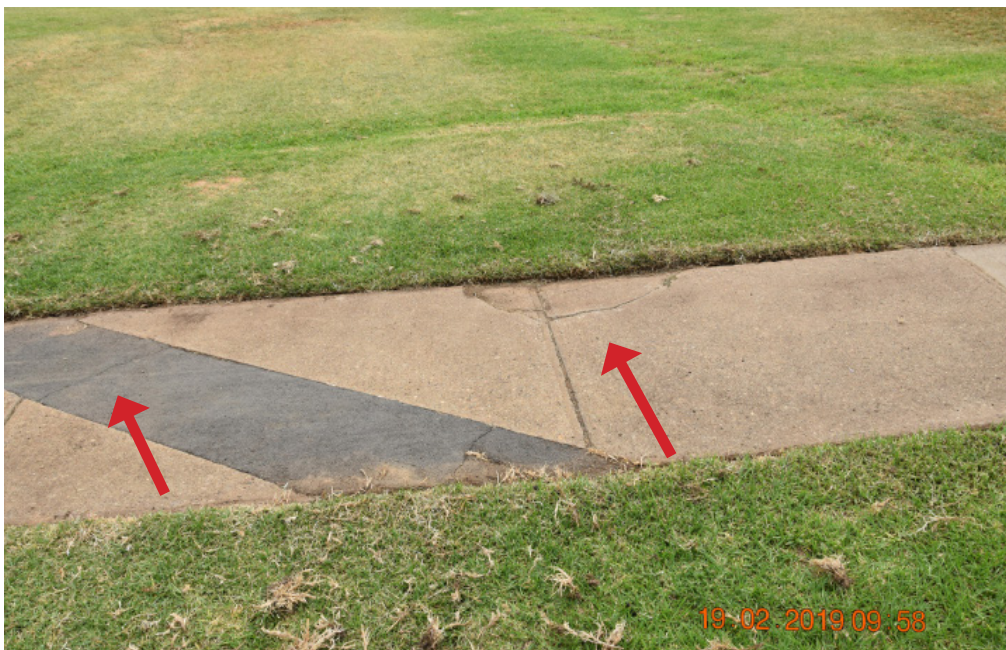
Figure: 0308

General view of the pathway near the southeast corner of the helipad. Showing cracking.

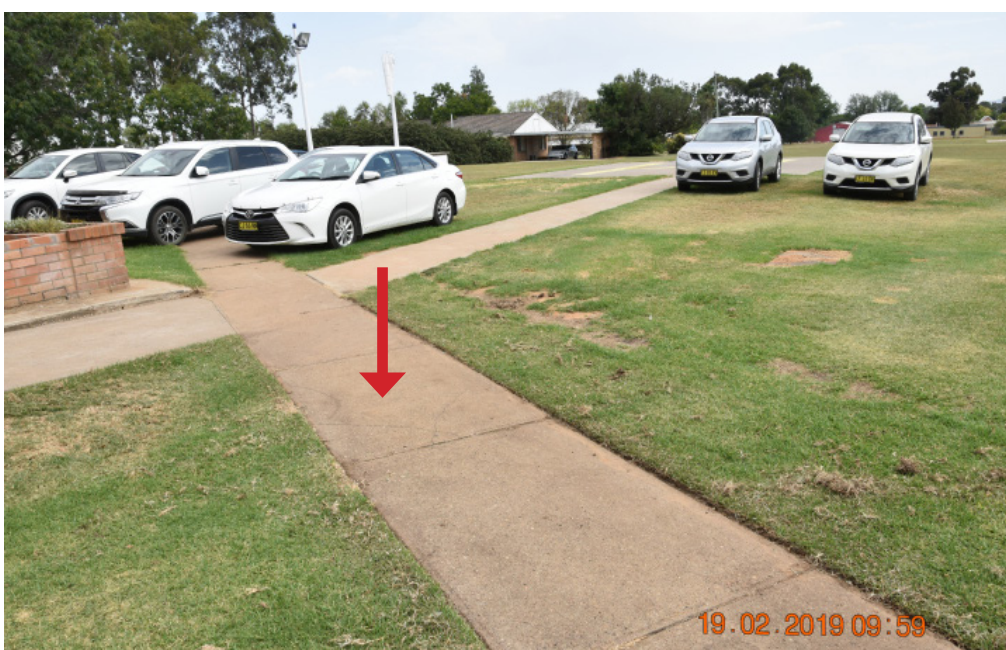
Figure: 0309

General view of the pathway near the southeast corner of the helipad. Showing cracking.

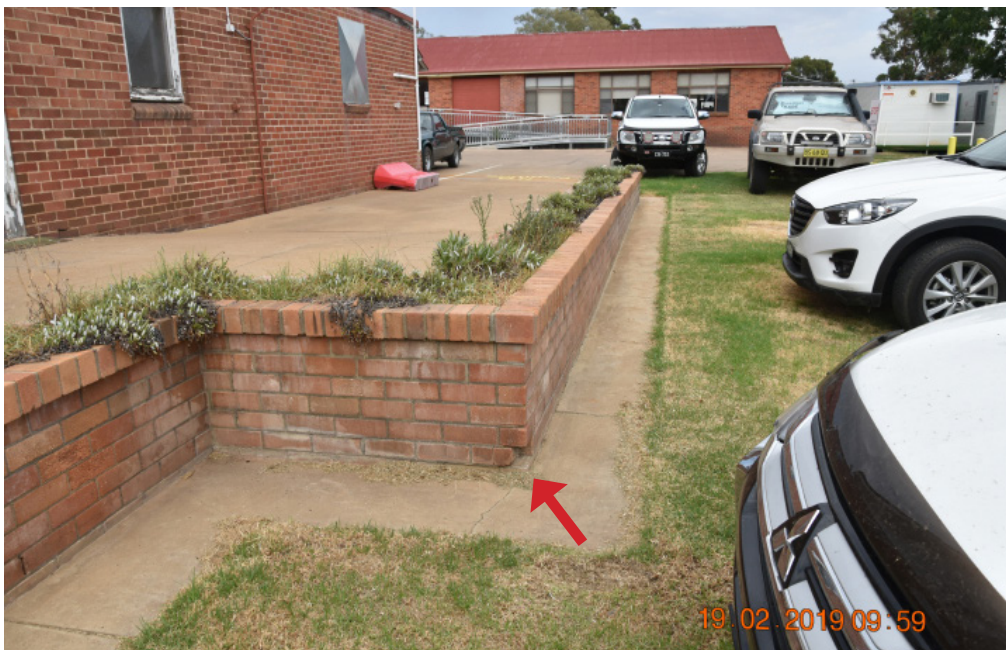
Figure: 0314

Retaining wall on the south side of the helipad. Showing missing brick.
